| <b>RIVIAN</b> | <b>SERVICE TOOL ENGINEERING QUALITY BULLETIN</b> | |
| | <b>Equipment: EP TORX, HV INSULATED SOCKETS</b> | <b>QB-TSN01557-300</b> |
| | <b>Rivian Tool ID: VARIOUS</b> | <b>Date: JUL 23 2026</b> |

Special Insulated sockets from Cementex, require minor rework for proper socket retention. The detent hole is blocked by insulation.

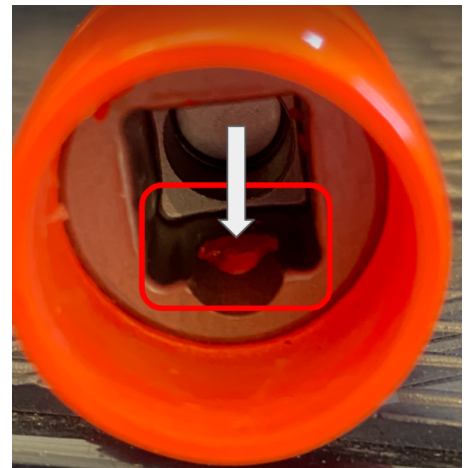
During the insulation dipping process, the socket detent hole was not plugged and PVC insulation was allowed to fill the detent retention hole in the socket square drive. This results in an undesirable condition where the socket detent may not hold the socket tightly and may not retain it under normal usage. The detent hole is supposed to be free and clear of insulation material.

Carefully use a **90 degree pick** and **Needle-nose pliers** to dig out insulation in the detent. Be careful not to puncture the pick through the insulation. The objective is to only remove any insulation filling the detent hole to the point where the detent can properly retain the socket. It's not necessary to remove 100% of the insulation, just enough for proper detent retention.
