TSN01349-100-A: 25 PIECE 3/8 DRIVE | PASS THROUGH SOCKET KIT | TOOL USE INSTRUCTIONS

USED TO REMOVE UPPER BALL JOINT NUT ON R1 BY HOLDING STUD FROM SPINNING WHILE BREAKING NUT LOOSE.

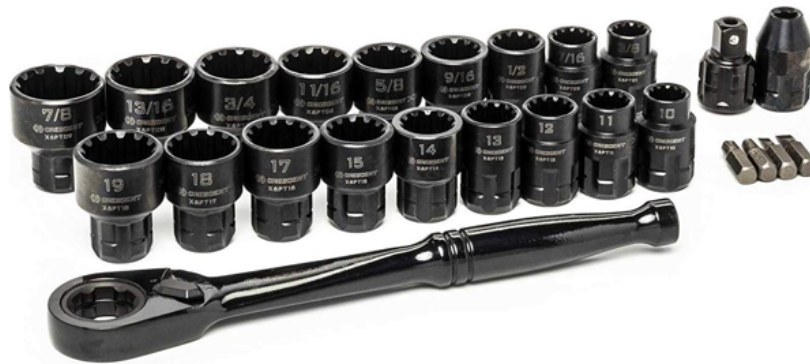
*NOTE THAT 13/16 SOCKET IS USED IN PLACE OF A 21MM.

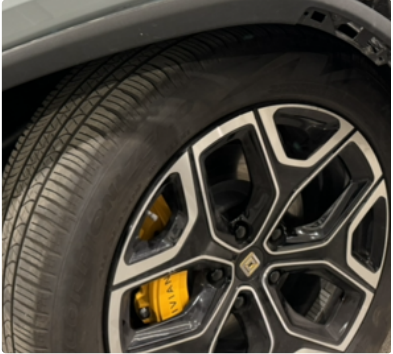
STEP	DIRECTIONS	VISUAL AID
1	<ul style="list-style-type: none">• Turn steering wheel so that wheel on side of work being performed is pointed inwards.

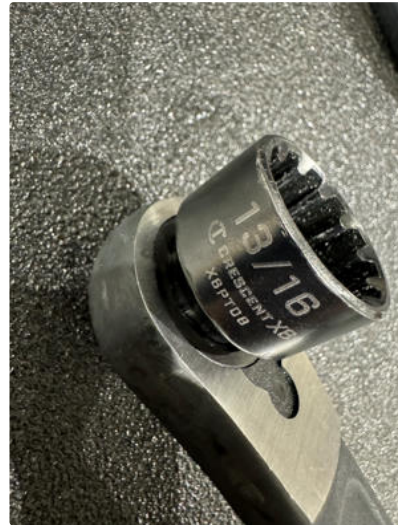
3

- Use the 13/16" (substitute for 21mm) socket with pass-through wrench to use on the backside of the steering knuckle, on the upper ball joint nut.

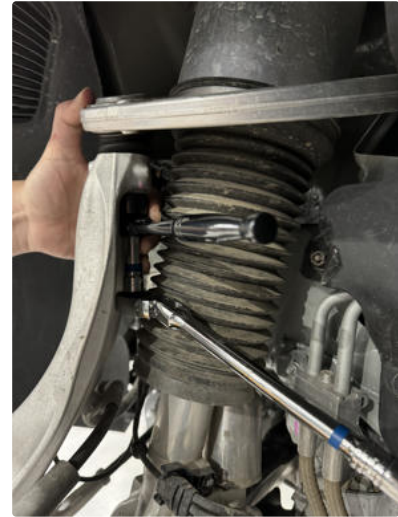
4

- Place the 13/16" socket/pass-through wrench assembly on the upper ball-joint nut.
- Place the 10mm deep socket, with 1/2" to 3/8" square adapter, connected to the 24" breaker-bar through pass through wrench opening, onto the ball joint threaded stud end.
- Turn the breaker-bar clockwise to break the ball joint nut free from the stud.
- Once broken free, rotate the ratcheting pass-through wrench counterclockwise to fully remove the 21mm nut.

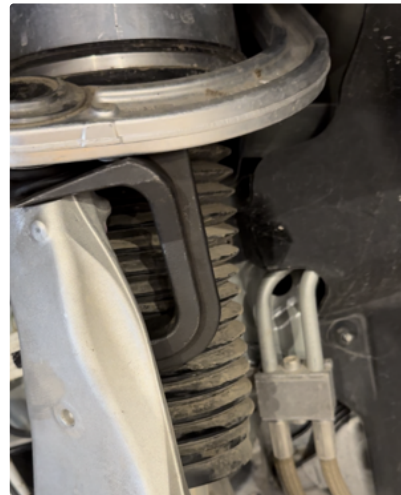
5

- Once the nut is removed, you may use a ball joint separator to break apart the upper arm from the steering knuckle assembly, if desired.

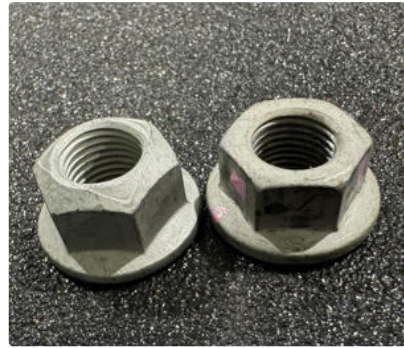
6

- Updated and or new parts such as new type upper-ball-joint nuts may be required for reinstallation. Refer to service manual and or service bulletins.
