TSN01449 | CAN BREAKOUT HARNESS, 76 POSITION

TOOL IS USED FOR R1 MODEL YEAR 2025 (PEREGRINE) CAN NETWORK BREAKOUT 76-WAY CONNECTOR FOUND AT THE VEHICLE IP TO BODY RH HARNESS INTERFACE

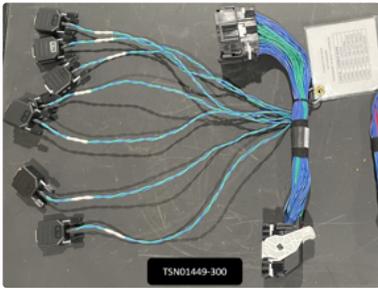
A photograph of a 76-position CAN breakout harness with multiple colored wires (blue, green, red, black) and various connectors. A label 'TSN01449-300' is visible at the bottom.
CAN2	C004 – PLATFORM	
CAN3	C012 – PRIMARY ACTUATOR	
CAN4	C013 – SECONDARY ACTUATOR	
CAN5	C017 – PRIMARY FRT OBJECT	
CAN6	C018 – SECONDARY FRT OBJECT	
CAN7	C028 – BODY FRONT	
CAN8	C020 – BODY REAR	TSN01448-300 CAN BREAKOUT HARNESS, 24 POSITION

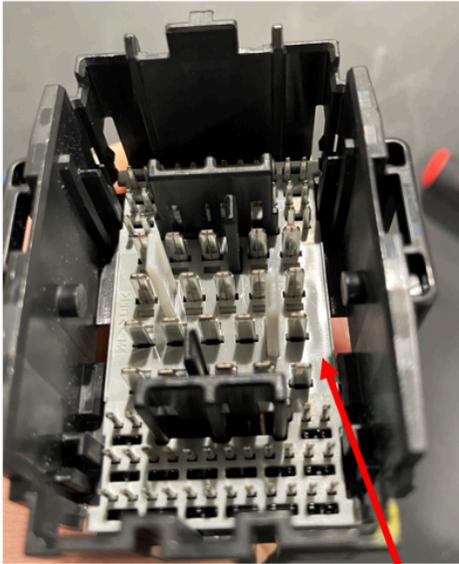
MBS DEPRESSED
TERMINALS UNSUPPORTED

- ❗ **Inspect male blade stabilizer (MBS)** on both vehicle and T-harness male connectors, ensure both are reset before mating T-harness with vehicle. Failure to reset may result in permanent damage to tool and/or vehicle connector.

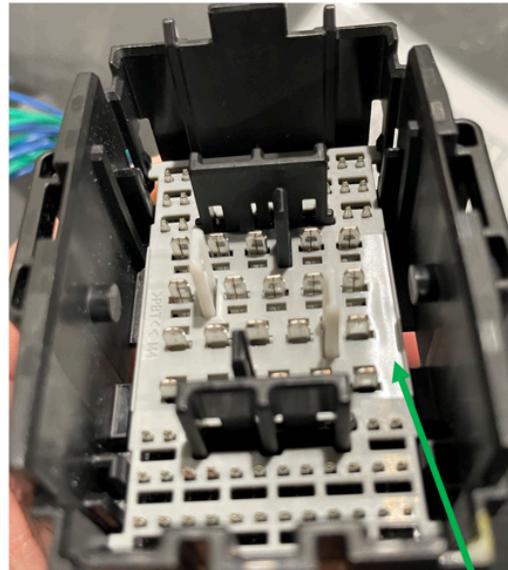
MBS RESET
TERMINALS SUPPORTED, READY TO CONNECT

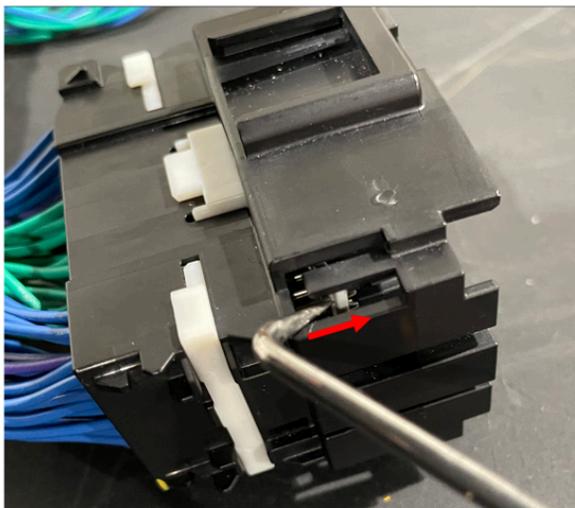
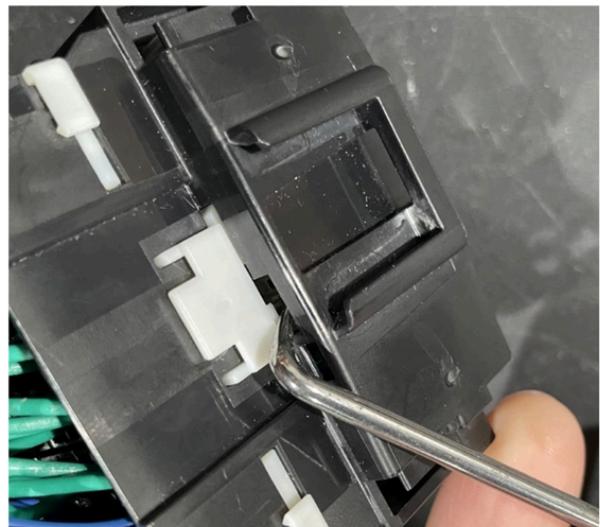
- ❗ **TO RESET MBS:** Use a 90 degree pick to carefully lift the MBS plate at 4x corner slots and 2x center slots of the male connector until MBS clicks fully into the reset position. Use care to avoid bending terminals while resetting MBS.

4 Once work is complete, carefully disconnect harness from vehicle.
Reset MBS on both the vehicle and T-harness male connectors.
Reconnect vehicle harness and verify system functionality.

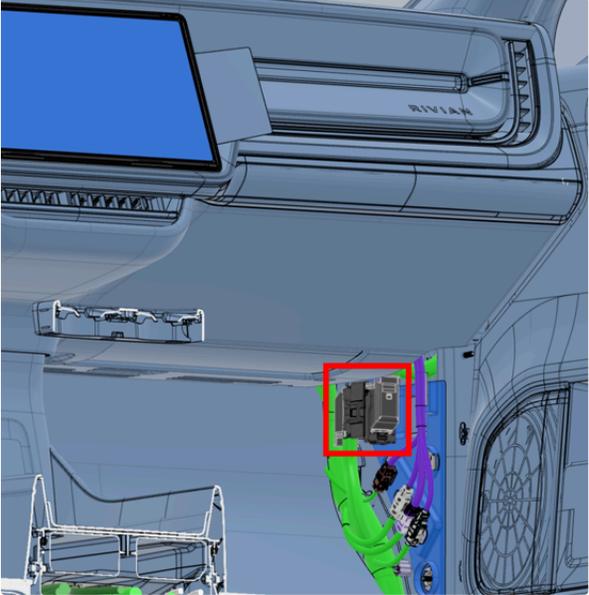
STEP	DIRECTIONS	VISUAL AID
1	<p>Locate vehicle 76 way connector - found beneath the instrument panel, RH side behind the side kick panel for both R1T and R1S.</p> <p>Remove trim as needed to access connector.</p>

<p>A 3D CAD rendering of the vehicle's interior, viewed from the driver's side looking towards the passenger side. The instrument panel and center console are visible. A red rectangular box highlights a component located beneath the instrument panel on the right side, which is the 76-way connector mentioned in the directions. The rendering is semi-transparent to show internal components.</p>
2	<p>Disconnect 76 way connection and reset MBS on male side of vehicle connector.</p> <p>Connect T-harness in-line with vehicle harness as shown</p> <div data-bbox="289 1115 816 1245" style="border: 1px solid #add8e6; padding: 5px;"><p>

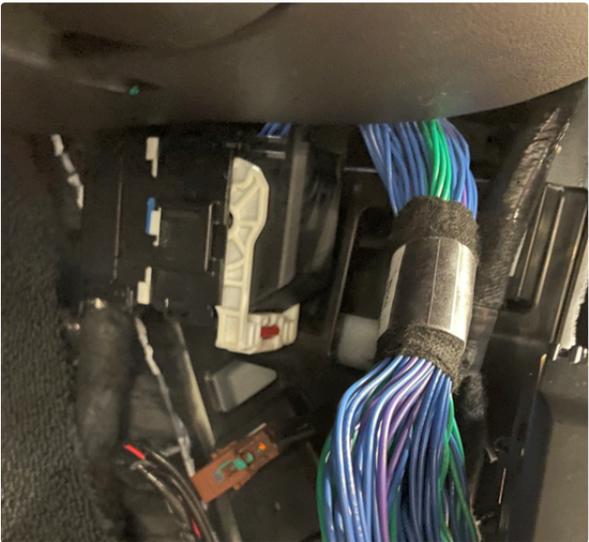
Male side of vehicle connector should remain clipped to the vehicle to avoid damage to connector body</p></div>

<p>A photograph showing a close-up of the male side of the vehicle connector. The connector is a large, cylindrical metal component with a bundle of multi-colored wires (blue, green, purple, etc.) extending from it. A T-harness is connected in-line with the vehicle harness. The background shows the interior of the vehicle, including the instrument panel and center console.</p> <p data-bbox="1036 1541 1230 1560">Male Side Vehicle Connector</p>

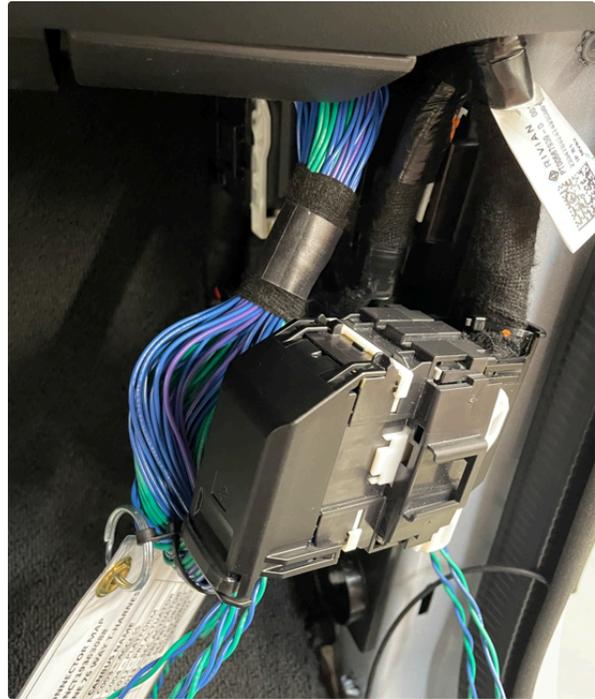
Female side vehicle connector
