| <b>RIVIAN</b> | <b>SERVICE TOOL ENGINEERING QUALITY BULLETIN</b> | |
| | <b>Equipment: EP TORX, HV INSULATED SOCKETS</b> | <b>QB-TSN01557-300</b> |
| | <b>Rivian Tool ID: VARIOUS</b> | <b>Date: JUL 23 2026</b> |

Special Insulated sockets from Cementex, require minor rework for proper socket retention. The detent hole is blocked by insulation.

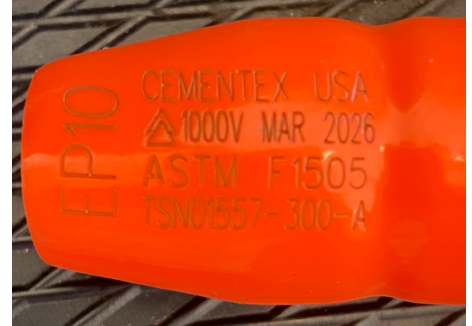
- TSN01539-300-A SOCKET, 1/4" DRIVE, EP8, INSULATED
- TSN01557-300-A SOCKET, 1/4" DRIVE, EP10, INSULATED
- TSN01540-300-A SOCKET, 3/8" DRIVE, EP14, INSULATED

During the insulation dipping process, the socket detent hole was not plugged and PVC insulation was allowed to fill the detent retention hole in the socket square drive. This results in an undesirable condition where the socket detent may not hold the socket tightly and may not retain it under normal usage. The detent hole is supposed to be free and clear of insulation material.

Carefully use a **90 degree pick** and **Needle-nose pliers** to dig out insulation in the detent. Be careful not to puncture the pick through the insulation. The objective is to only remove any insulation filling the detent hole to the point where the detent can properly retain the socket. It's not necessary to remove 100% of the insulation, just enough for proper detent retention.
