TSN01389: Washer Fluid Reservoir Line Cap - Service Tool

This tool is used on R1 MY 2025> for Front Fascia removal to plug the washer fluid line (used for front fascia camera cleaning).

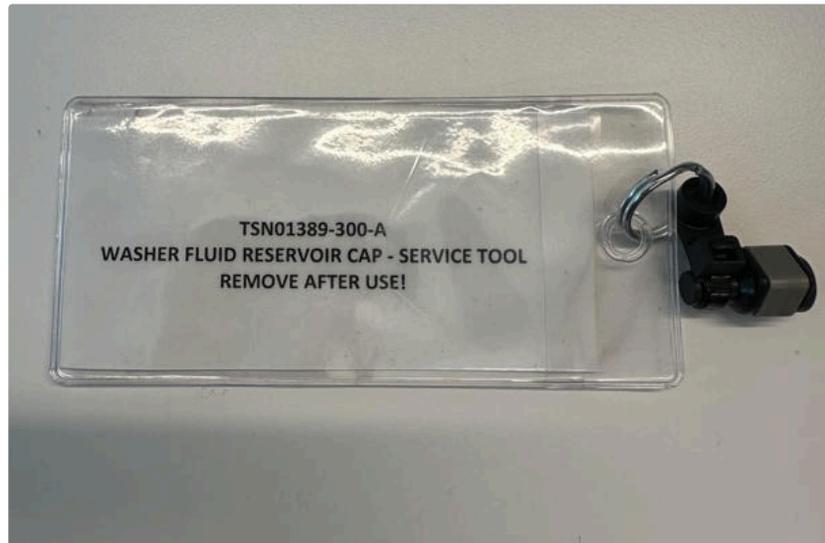
This can also be used in any instance that the washer fluid line needs to be disconnected from a connection point or from the washer reservoir and you want to prevent losing washer fluid in the process.

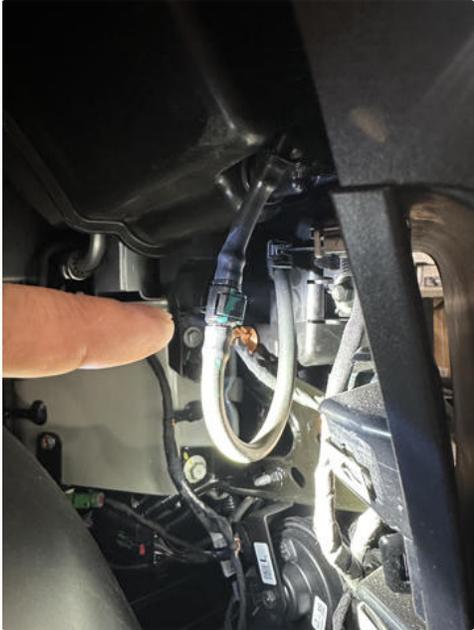
STEP	DIRECTIONS	VISUAL AID
1	<p>Locate washer line going to washer reservoir coming from the Front Fascia.</p> <p>i This is located on the Passenger side of the vehicle behind the front wheel liner.</p>

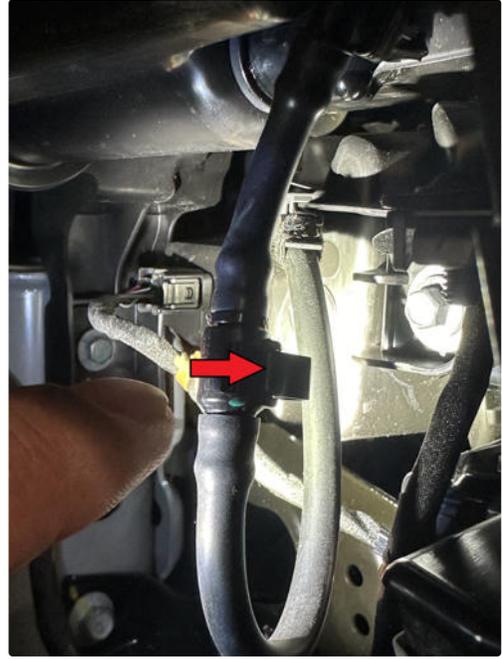
2	<p>Disconnect at the coupler point.</p> <p>You may lose a small amount of fluid during this process! Be sure to have an absorption rag handy.</p> <p>i You will need to use a pocket screw driver or a small pick to slide the coupler lock back. This will allow you to disconnect the line (fascia side) from the washer reservoir line.</p>

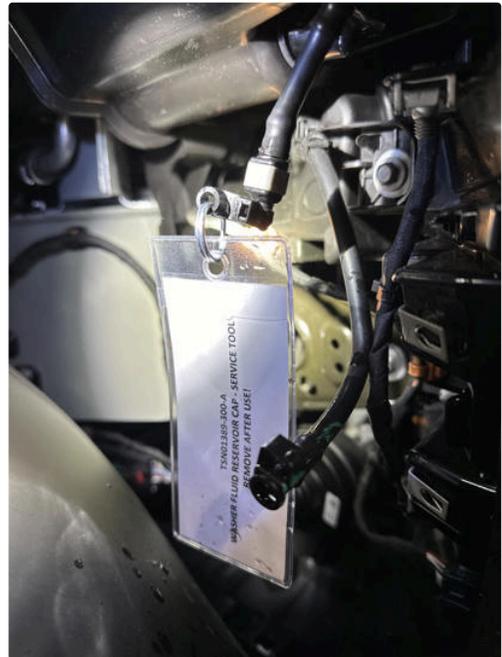
3

Once the coupler connection is disconnected, attach **TSN01389-300 WASHER FLUID RESEVOIR CAP** onto the washer line on the reservoir side.
